47<sup>TH</sup> TURBOMACHINERY & 34<sup>TH</sup> PUMP SYMPOSIA  
HOUSTON, TEXAS | SEPTEMBER 17-20, 2018  
GEORGE R. BROWN CONVENTION CENTER

# Compressor Dry Gas Seal Failure Due To Oil Ingress

Service: RGC, Recycle Gas (Hydrogen)

Location: Hydrotreater, Refinery

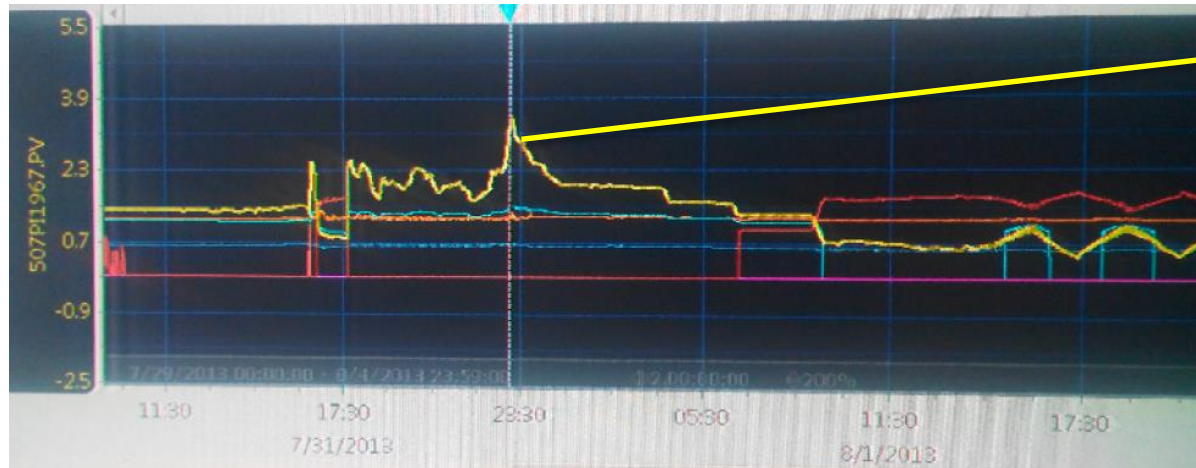
1. On 31.07.2013, RGC tripped on a high process value (Unit upset).
2. Compressor re-start planned in settle out condition.
3. Make up Gas (MUG) compressor discharge lined-up to primary seal gas supply.
4. After the RGC start-up (on 31.07.2013), DE side DGS - primary seal vent pressure increased to 3.3 kg/cm<sup>2</sup> g (Alarm limit of 3 kg/cm<sup>2</sup> g). Same location vent flow also increased to 35-36 Nm<sup>3</sup>/hr.

DE side  
primary seal  
vent pressure

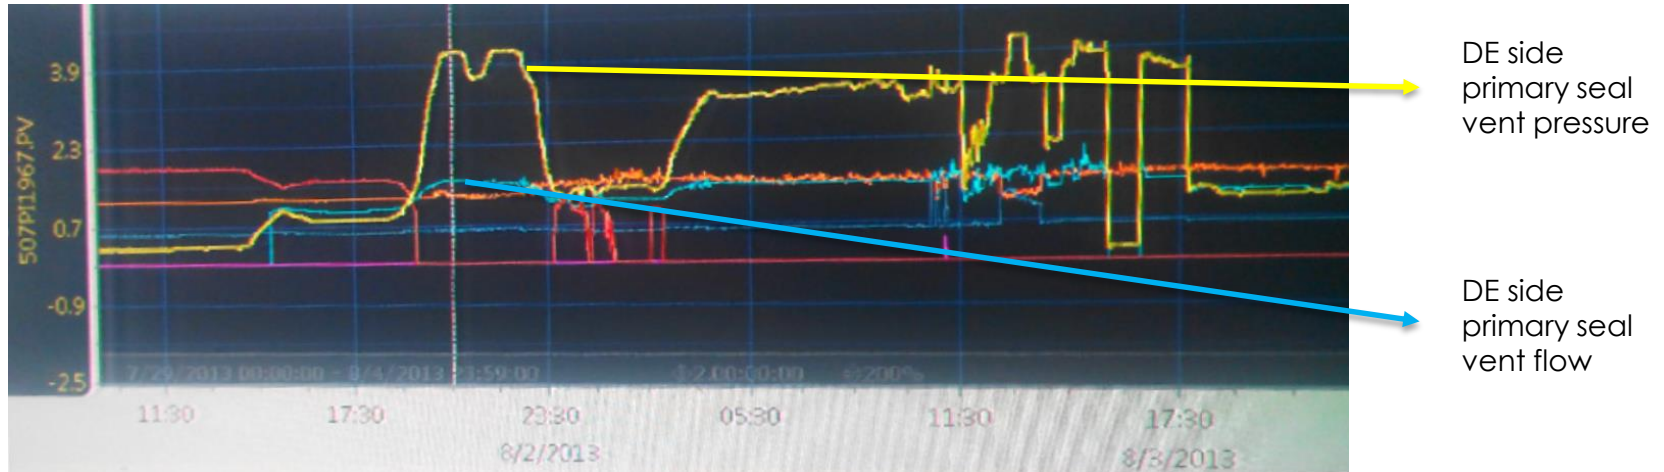
6. On 02.08.2013, DE side primary seal vent pressure and flow further increased to 4.2 kg/cm<sup>2</sup>g and 37 Nm<sup>3</sup>/hr respectively. Subsequently DE side secondary seal flow also dropped due to high primary seal vent pressure.

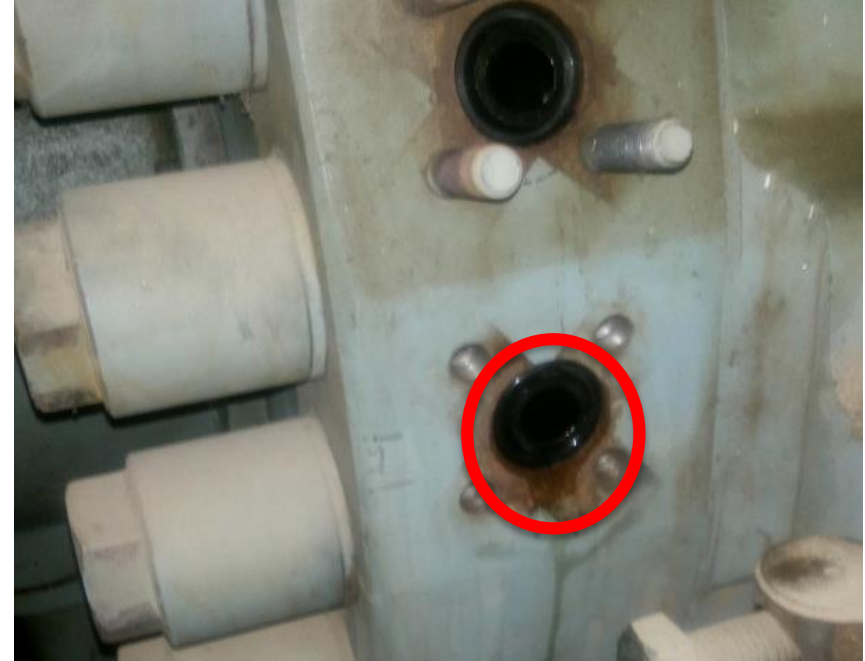
Seal gas supply port

1. DE Side seal found with the heavy oil ingresses
2. Seal gas supply ports flooded with oil
3. NDE seal also found contaminated with oil

1. Compressor both ends dry gas seals replaced with spare seals, pipe lines cleaned, filters replaced.
2. A dedicated pipeline erected from hydrogen storage bullet to supply clean hydrogen for primary seal during start-ups. Original make-up gas compressor discharge line for primary seal disconnected and blinded off.
3. Safe filter draining provision provided and being drained at regular intervals.

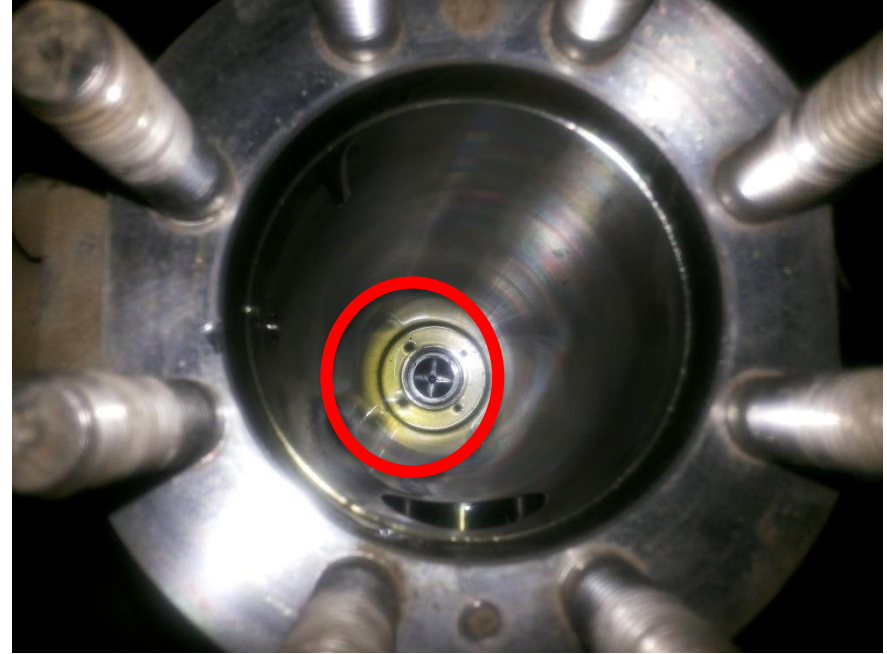
Filter Housing

- 4. Oil found in seal gas filter housing
- 5. Carbon particles in the DE side seal, presumed to be from seal face
- 6. NO traces of oil in the separation seal system

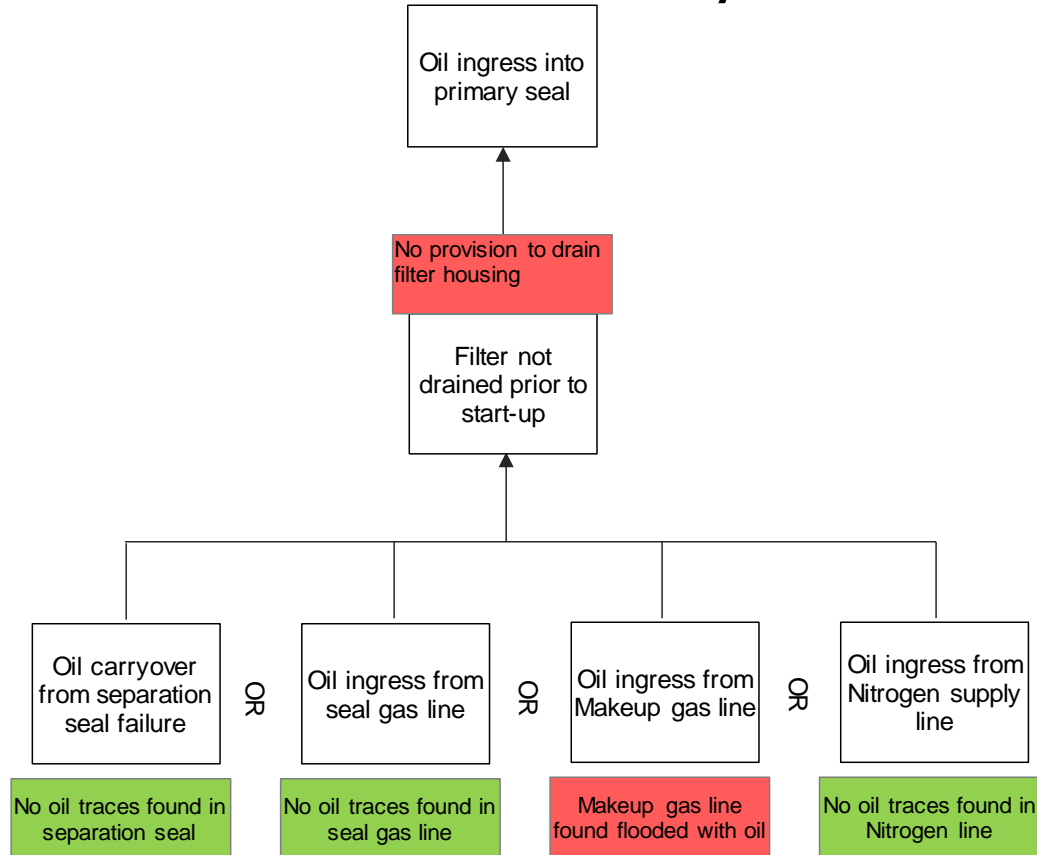
- Make-up gas (Hydrogen) is supplied from a makeup gas compressor discharge, which is a reciprocating machine
- Make up gas compressor has Lubricated cylinder design
- Oil found in the pipeline from Make-up Gas compressor discharge and also in its inter-stage knockout drum.
- Seal gas filter were designed to remove moisture but no safe draining provision in filter housing.
- Above led to oil entry into Dry Gas seal , resulting into its failure

1. Provision of separate primary seal gas supply line from hydrogen bullet (storage) for compressor start-up / shutdown case, in place of make up gas compressor discharge gas.
2. Provision of safe seal gas filter draining mechanism
3. Update project stage specifications to include coalescing filters in seal gas supply along with filter drain pots to collect condensed liquid
